# Full-scale testing of 230kV FRP poles

Compare full-scale FRP pole testing results with PLS-POLE™ simulation

- 230kV suspension structure: H-frame
- 230kV 90 degree dead-end Pole: Representing Guyed pole from 3 pole dead-end

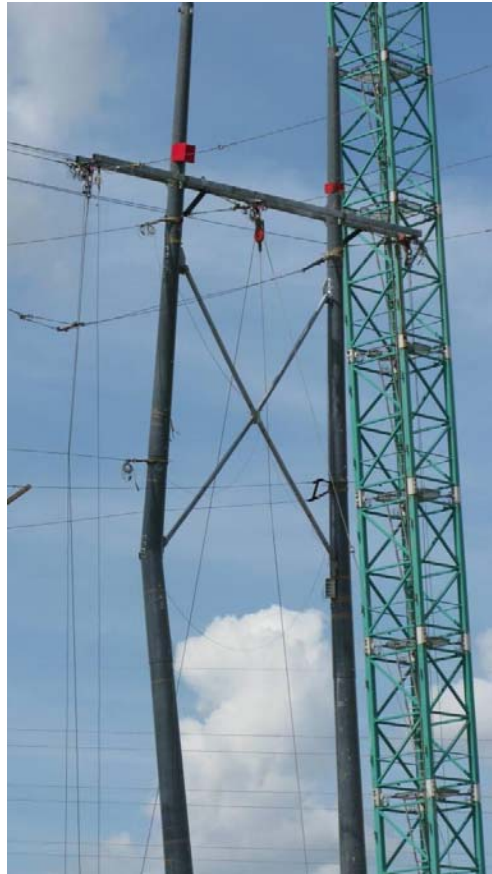
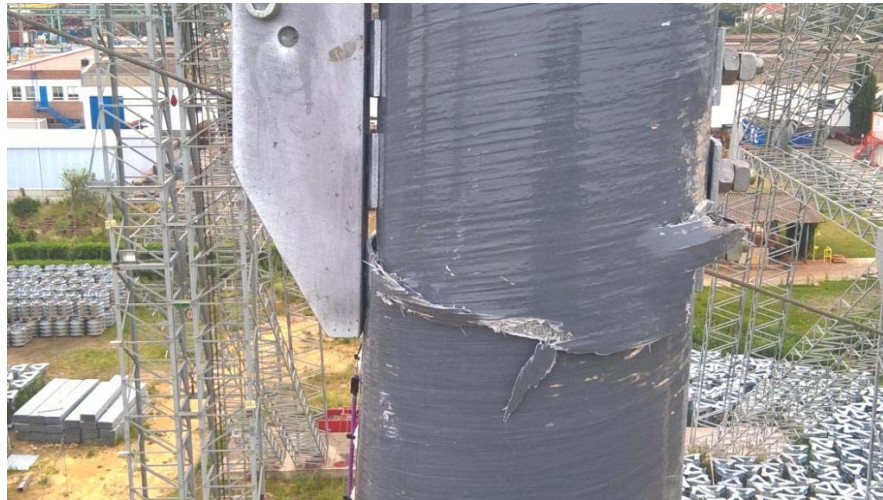
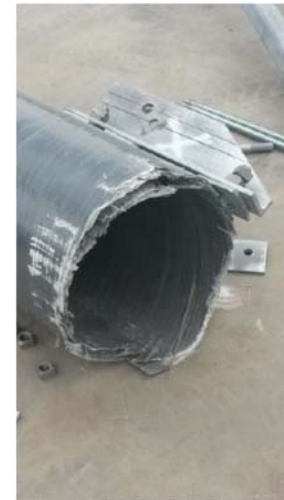
# H-frame Test #9: 1320 Pa wind

H-frame FRP pole failure video

- PLS-POLE™ FRP H-frame analysis predicted the following:
  - conservative results for deflection of the H-frame test with loads in all 3 directions
  - consideration of the local pole usage near holes was required to predict the failure point.
  - More accurate results for simple load cases in only 2 directions
- X-brace pin bolt failed because it was overloaded. A larger bolt was required
- PLS-POLE™ FRP analysis accurately predicted the buckling load and deflected shape of the 90 degree dead end monopole.

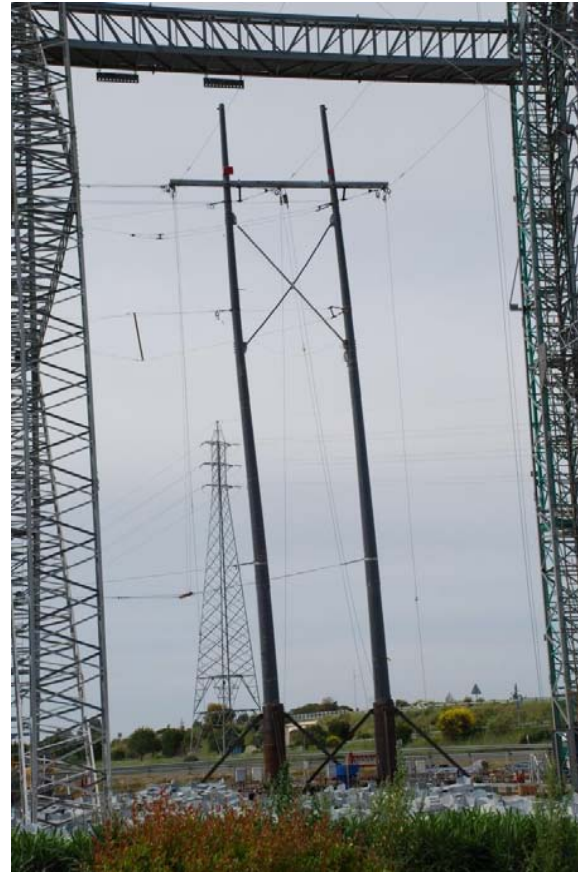
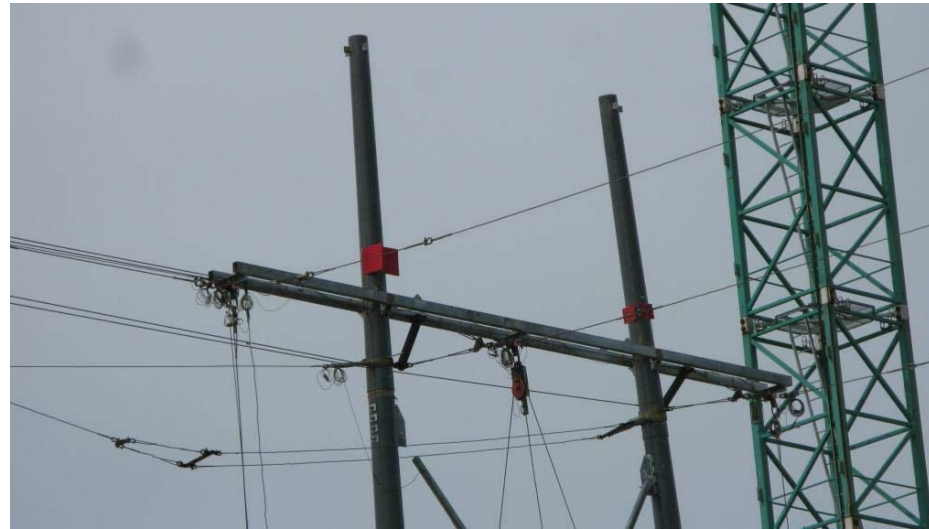
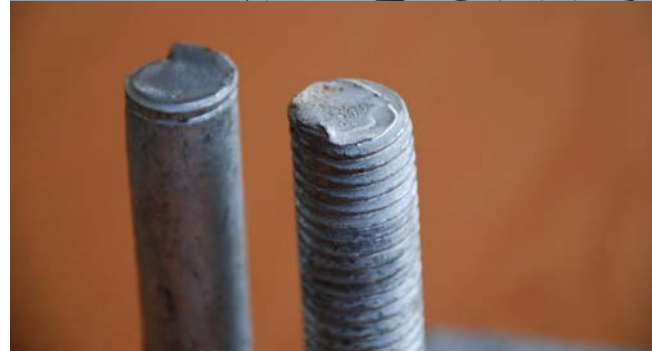
# H-frame Test : Bolt failure

- The bolt failed due to overload, based on evidence from fractographic examination and shear strength testing.

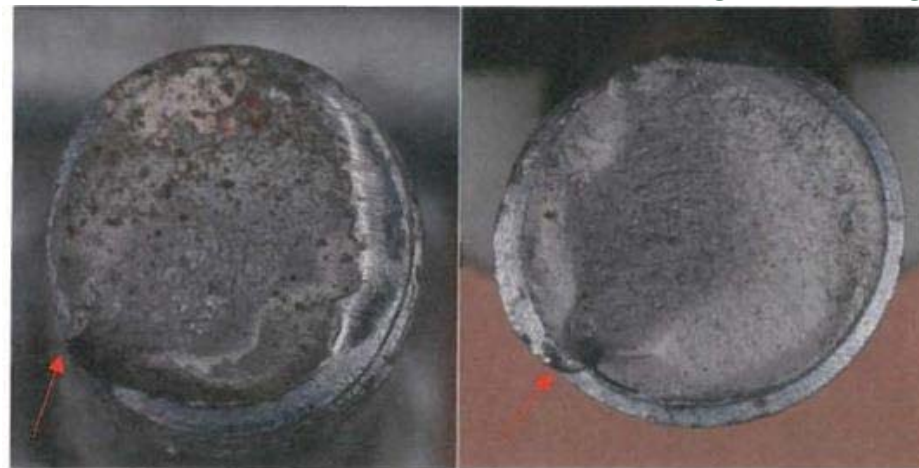
**Figure 2.** Composite image of the bolt fracture surfaces on: (a) the threaded portion, (b) the un-threaded portion. A shear lip on both surfaces, likely the location of final fracture, is indicated with an arrow.

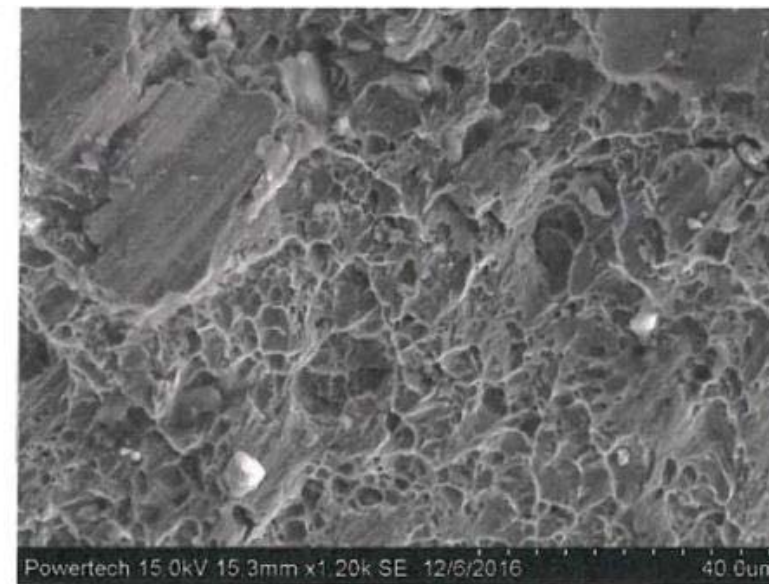
**Figure 3.** SEM image of the fracture surface, showing dimples, which are consistent with overload. Some smearing due to mechanical damage is also present (top left).
