# Full-scale testing of 230kV FRP poles

Compare full-scale FRP pole testing results with PLS-POLE™ simulation

- 230kV suspension structure: H-frame
- 230kV 90 degree dead-end Pole: Representing Guyed pole from 3 pole dead-end

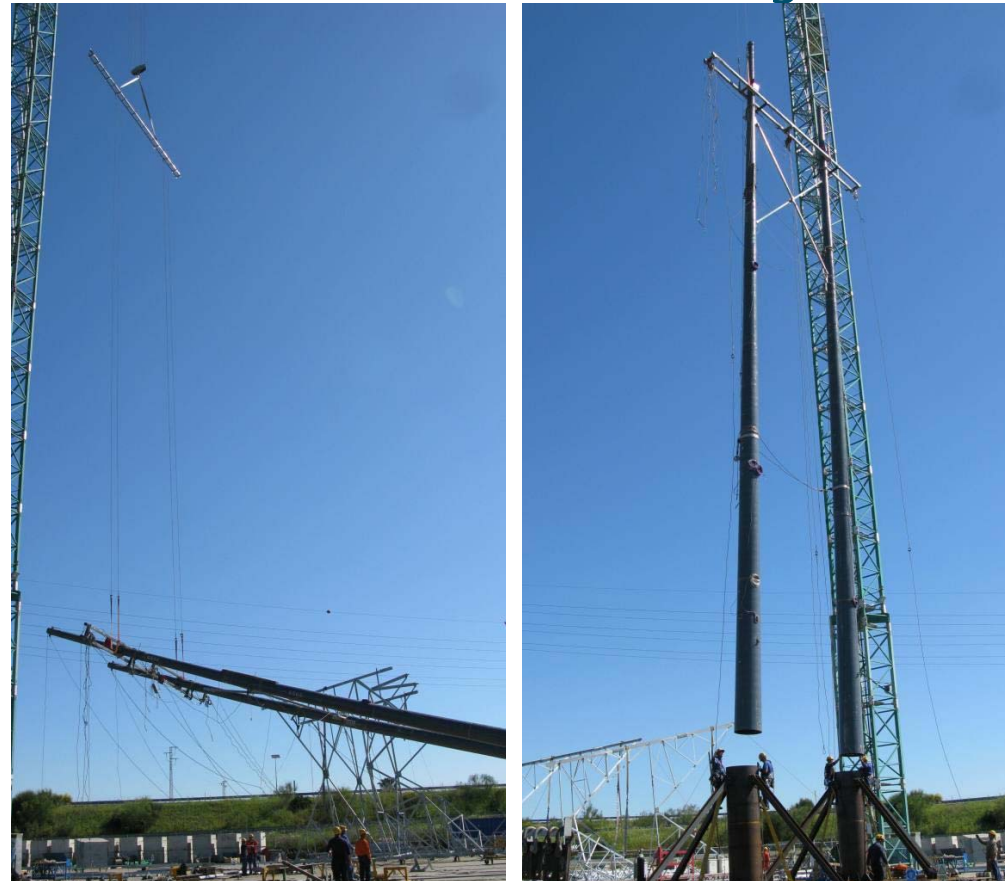
# H-frame Assembly

- Structure was framed on the ground
- Hardware supplied by BCH
- Hardware was adapted from existing wood pole hardware (BCH Standard 41I)
- Hardware fitting issues
- ABENGOA fabricated hardware for the FRP structures on site
- FRP pole testing schedule delays
- BCH hardware failed during H-frame testing
- Soil was not properly compacted in canisters

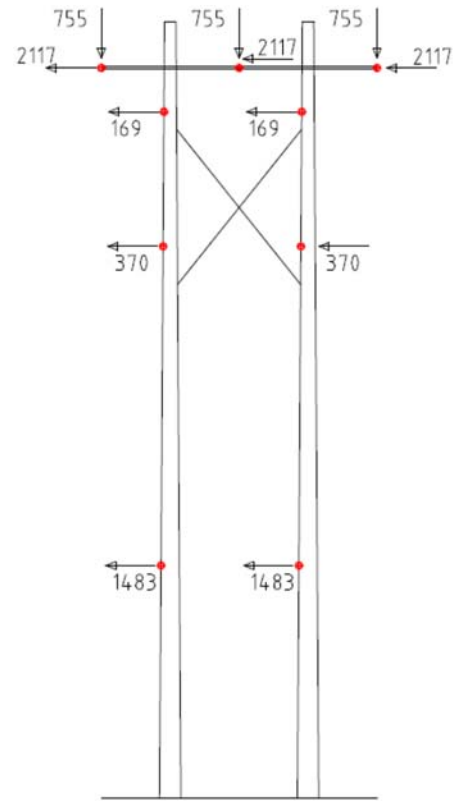
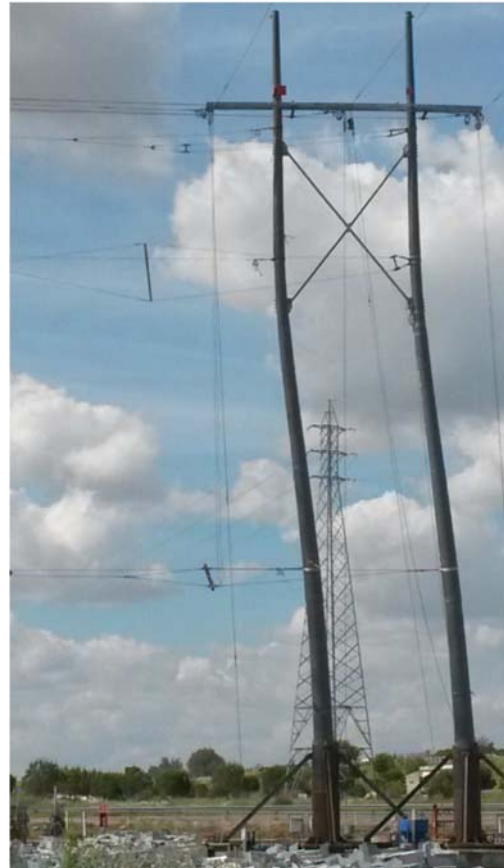
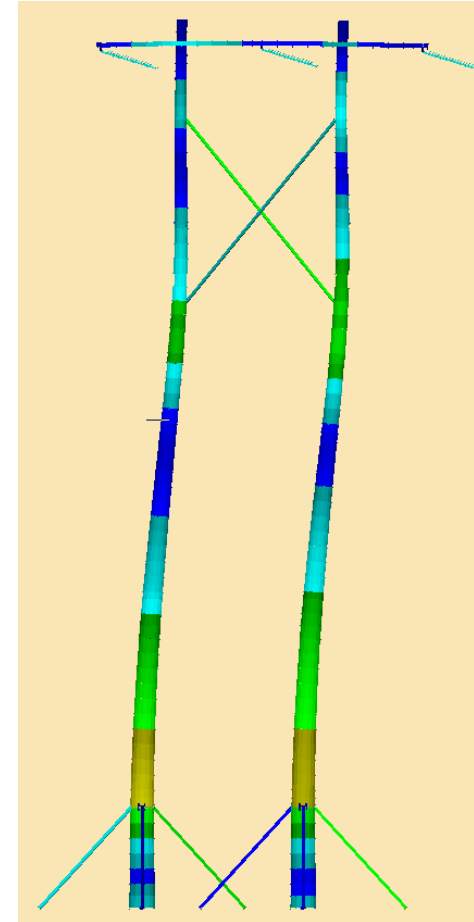
# H-frame Test #9: 1320 Pa wind

Test #9, High Wind [1320 Pa] With Point Load WR  
[Tangent Str.], L NA+
